# **Technical Report**

Report No. R12764

Porcelanosa-Butech System Test
CWCT Test Sequence
Project Ref. 12764

Product/System Tested: Porcelanosa-Butech System

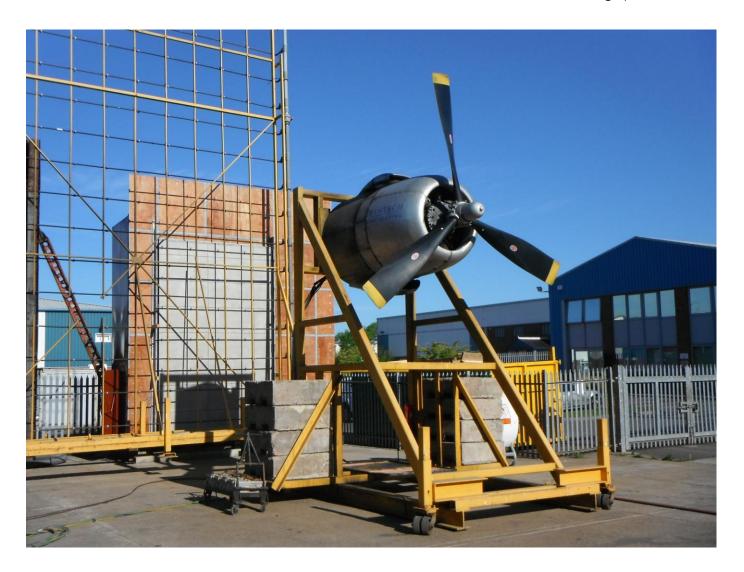
# Photograph No. 1

# <u>Test Sample During Testing</u>

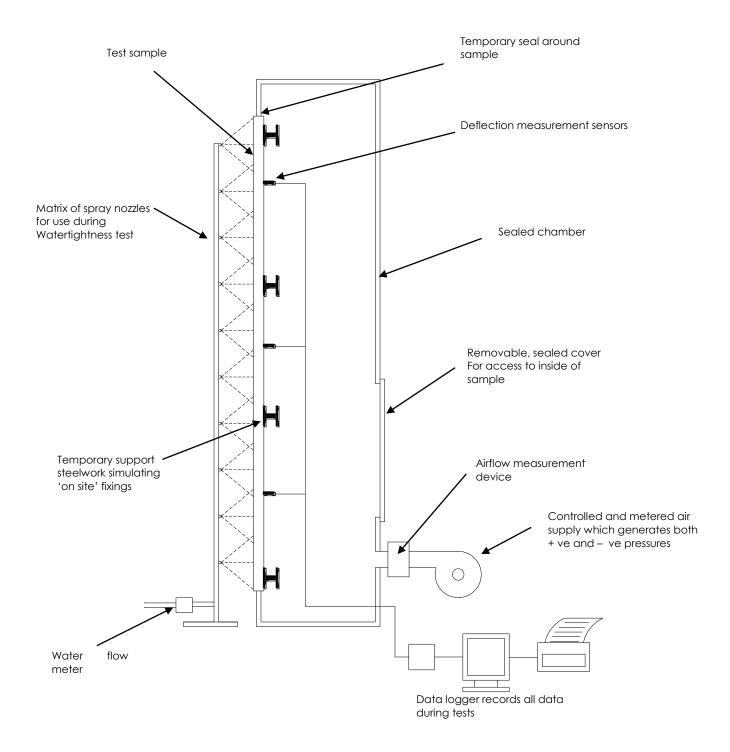
# Figure 1

# General Arrangement of a Typical Test Assembly

A Rainscreen specimen, supplied for testing in accordance with CWCT requirements, was mounted on to a rigid test chamber constructed from steel, timber and plywood sheeting.

The pressure within the chamber was controlled by means of a centrifugal fan and a system of ducting and valves. The static pressure difference between the outside and inside of the chamber was measured by means of a differential pressure transmitter.

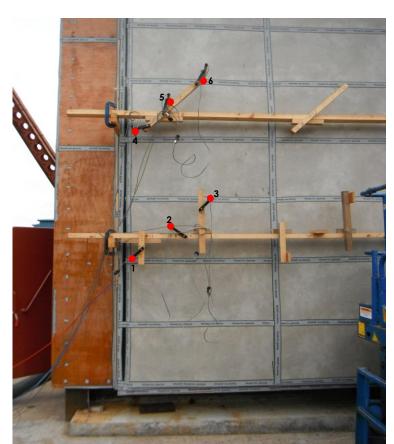
Figure 2

# <u>Positions of Deflection Measurement Probes</u>

View from Outside

Group A comprised of probes 1, 2 & 3 = Probe 2 - ((Probe 1 + Probe 3)/2) Group B comprised of probes 4, 5, & 6

= Probe 5 - ((Probe 4 + Probe 6)/2)

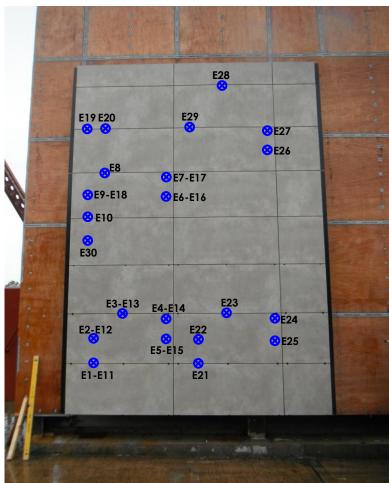
Figure 3

# 6.3.3 Impact Positions

View from outside – Not to scale

Impact Reference	Test Category	Impactor Type	Impact Energy (Nm)	Drop Height (mm)	Observations	Result
El	В	\$1	120	245	Bounce and small piece fell from in front of fixing clip	Pass
E2	В	\$1	120	245	Bounce	Pass
E3	В	\$1	120	245	Bounce	Pass
E4	В	\$1	120	245	Bounce	Pass
E5	В	\$1	120	245	Bounce	Pass
E6	В	\$1	120	245	Bounce	Pass
E7	В	\$1	120	245	Bounce	Pass
E8	В	\$1	120	245	Bounce	Pass
E9	В	\$1	120	245	Bounce	Pass
E10	В	\$1	120	245	Bounce	Pass
E11	В	H2	10	898	Bounce & Spalling	Pass
E12	В	H2	10	898	Bounce	Pass
E13	В	H2	10	898	Bounce & Spalling	Pass
E14	В	H2	10	898	Bounce and corner cracked – safely retained	Pass
E15	В	H2	10	898	Bounce and cracked – safely retained	Pass
E16	В	H2	10	898	Bounce and cracked – safely retained	Pass
E17	В	H2	10	898	Bounce and corner cracked – safely retained	Pass
E18	В	H2	10	898	Bounce and crack from top to bottom of tile	Pass
E19	В	H2	10	898	Bounce and cracked – safely retained	Pass
E20	В	H2	10	898	Bounce and small piece fell from in front of fixing clip	Pass

Impact Reference	Test Category	Impactor Type	Impact Energy (Nm)	Drop Height (mm)	Observations	Result
E21	В	\$1	500	1020	Bounce	Pass
E22	В	\$1	500	1020	Bounce	Pass
E23	В	\$1	500	1020	Bounce	Pass
E24	В	\$1	500	1020	Bounce	Pass
E25	В	\$1	500	1020	Bounce	Pass
E26	В	\$1	500	1020	Bounce	Pass
E27	В	\$1	500	1020	Bounce and small piece fell from in front of fixing clip	Pass
E28	В	\$1	500	1020	Bounce and small piece fell from in front of fixing clip	Pass
E29	В	\$1	500	1020	Impactor penetrated tile leaving sharp edges which were safely retained	Pass
E30	В	\$1	500	1020	Impactor penetrated tile leaving sharp edges which were safely retained	Pass

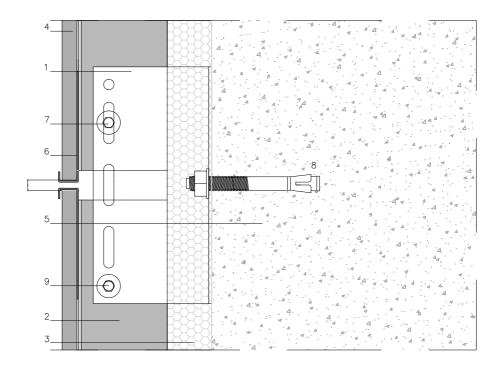
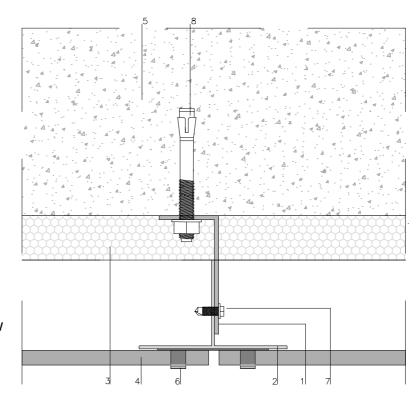
# | Visible system. Vertical & horizontal sections

- 1. L-bracket
- 2. T-profile
- 3. Thermal insulation
- 4. Ston-ker ceramic tile
- 5. Concrete substrate
- 6. Visible central clamp
- 7. SN5 self-drilling screw
- 8. Bolt anchor

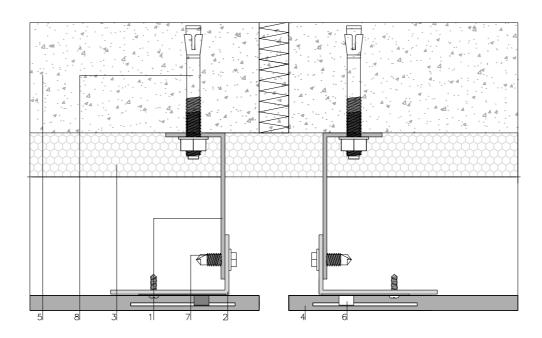
# | Installation on existing expansion joints

- 1. L-bracket
- 2. L-profile
- 3. Thermal insulation
- 4. Ston-ker ceramic tile
- 5. Concrete
- 6. Invisible lateral clamp
- 7. SN5 self-drilling screw
- 8. Bolt anchor

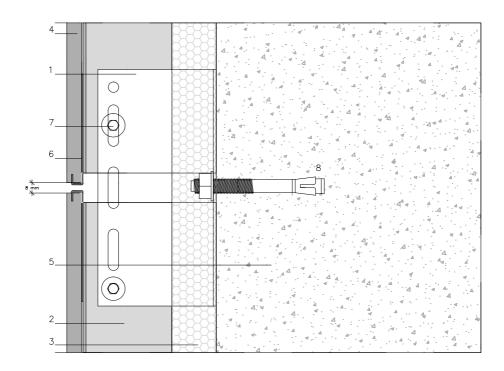
# | Expansion joint between profiles

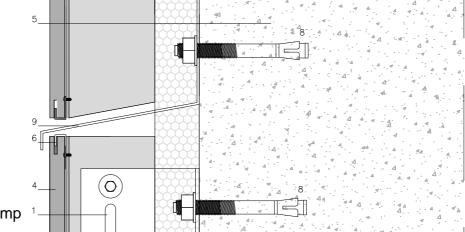
# | Interruption of the ventilated air gap

- 1. L-bracket
- 2. T-profile
- 3. Thermail insulation
- 4. Ston-ker ceramic tile
- 5. Concrete
- 6. Invisible starting-finishing clamp
- 7. SN5 self-drilling screw
- 8. Bolt anchor
- 9. Aluminium plate

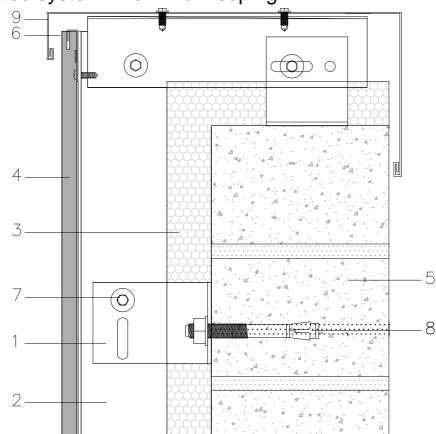
# | Concealed system. Ceramic coping 0 8

- 1. L bracket
- 2. T profile
- 3. Thermal insulation
- 4. Ston-ker ceramic tile
- 5. Substrate wall
- 6. Concealed clip
- 7. SN5 self-drilling screw
- 8. Bolt anchor
- 9. Ceramic coping

- 1. L bracket
- 2. T profile
- 3. Thermal insulation
- 4. Ston-ker ceramic tile
- 5. Substrate wall
- 6. Concealed clip
- 7. SN5 self-drilling screw
- 8. Bolt anchor
- 9. Aluminium coping

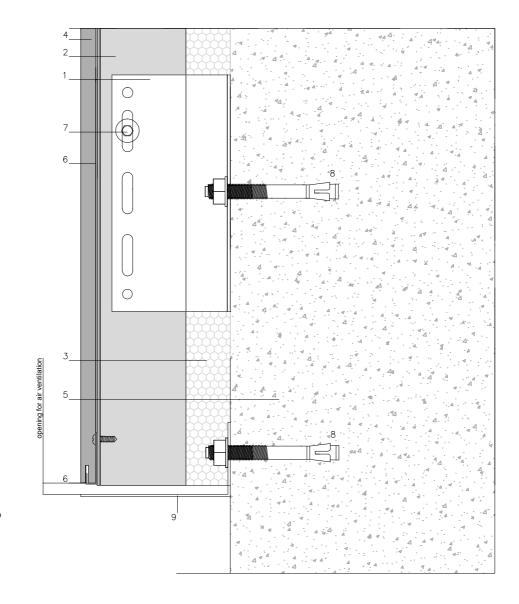
# | Starting

- 1. L Bracket
- 2. T Profile
- 3. Thermal insulatiom
- 4. Ston-Ker tile
- 5. Concrete
- 6. Start/ending concealed clip
  7. Self drilling screw SN5
  8. Anchor

- 9. Aluminium plate

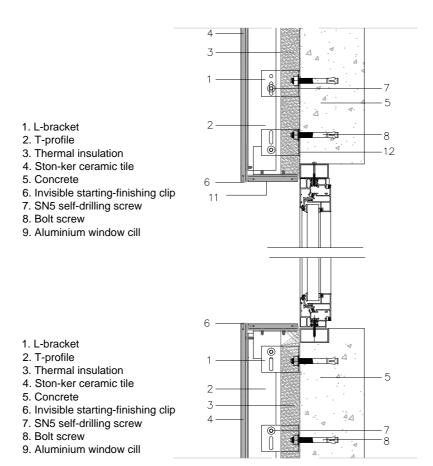
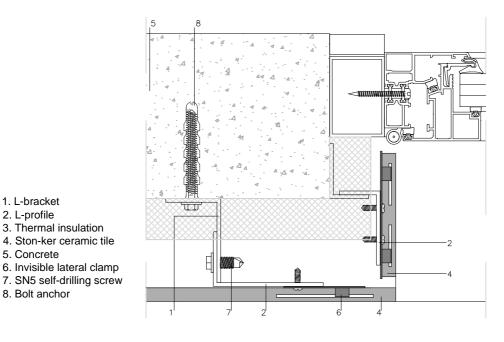
# | Window frames - Vertical & horizontal sections

1. L-bracket 2. L-profile

3. Thermal insulation 4. Ston-ker ceramic tile

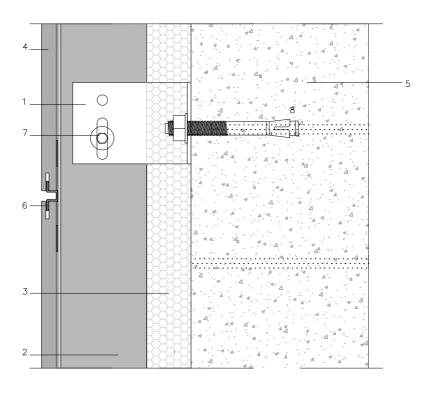
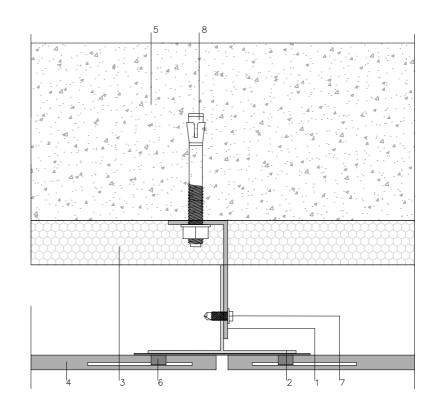
# | Concealed system. Vertical & horizontal section

- 1. L-bracket
- 2. T-profile
- 3. Thermal insulation
- 4. Ston-ker ceramic tile
- 5. Concrete
- 6. Invisible central clamp
- 7. SN5 self-drilling screw
- 8. Anchor

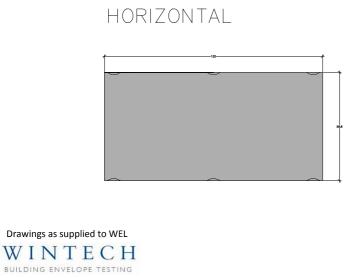
# | Grooving of ceramic tiles (according to size and type of tile layout)

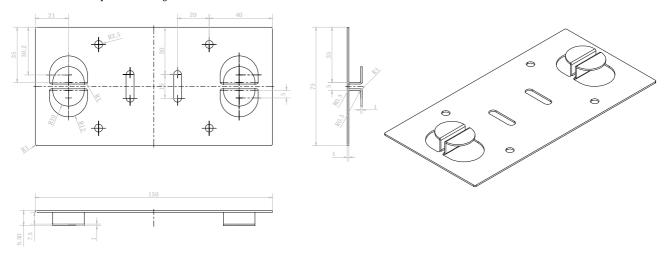
# | Concealed central clip for 5 mm joint

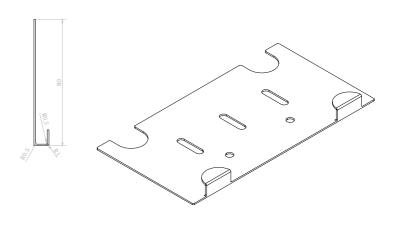
# | Starting-finishing concealed clip for 5 joint

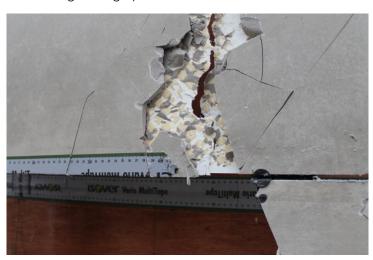
# Dismantling Photograph No. 3

← Showing fibre glass sheet on back of tile tested

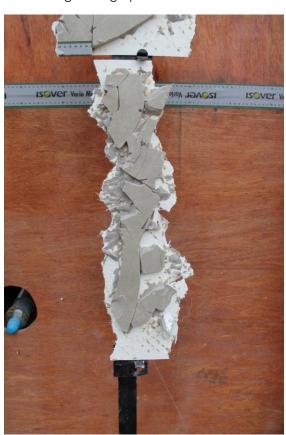
# Dismantling Photograph No. 5

← Showing tile with fibre glass sheet on support rail due to bonding applied to back of tiles
